**Heather and Hillforts Survey Report:  
Moel y Gaer, Lantysilio**

**EAS Survey Report 2007/01**

**January 2007**

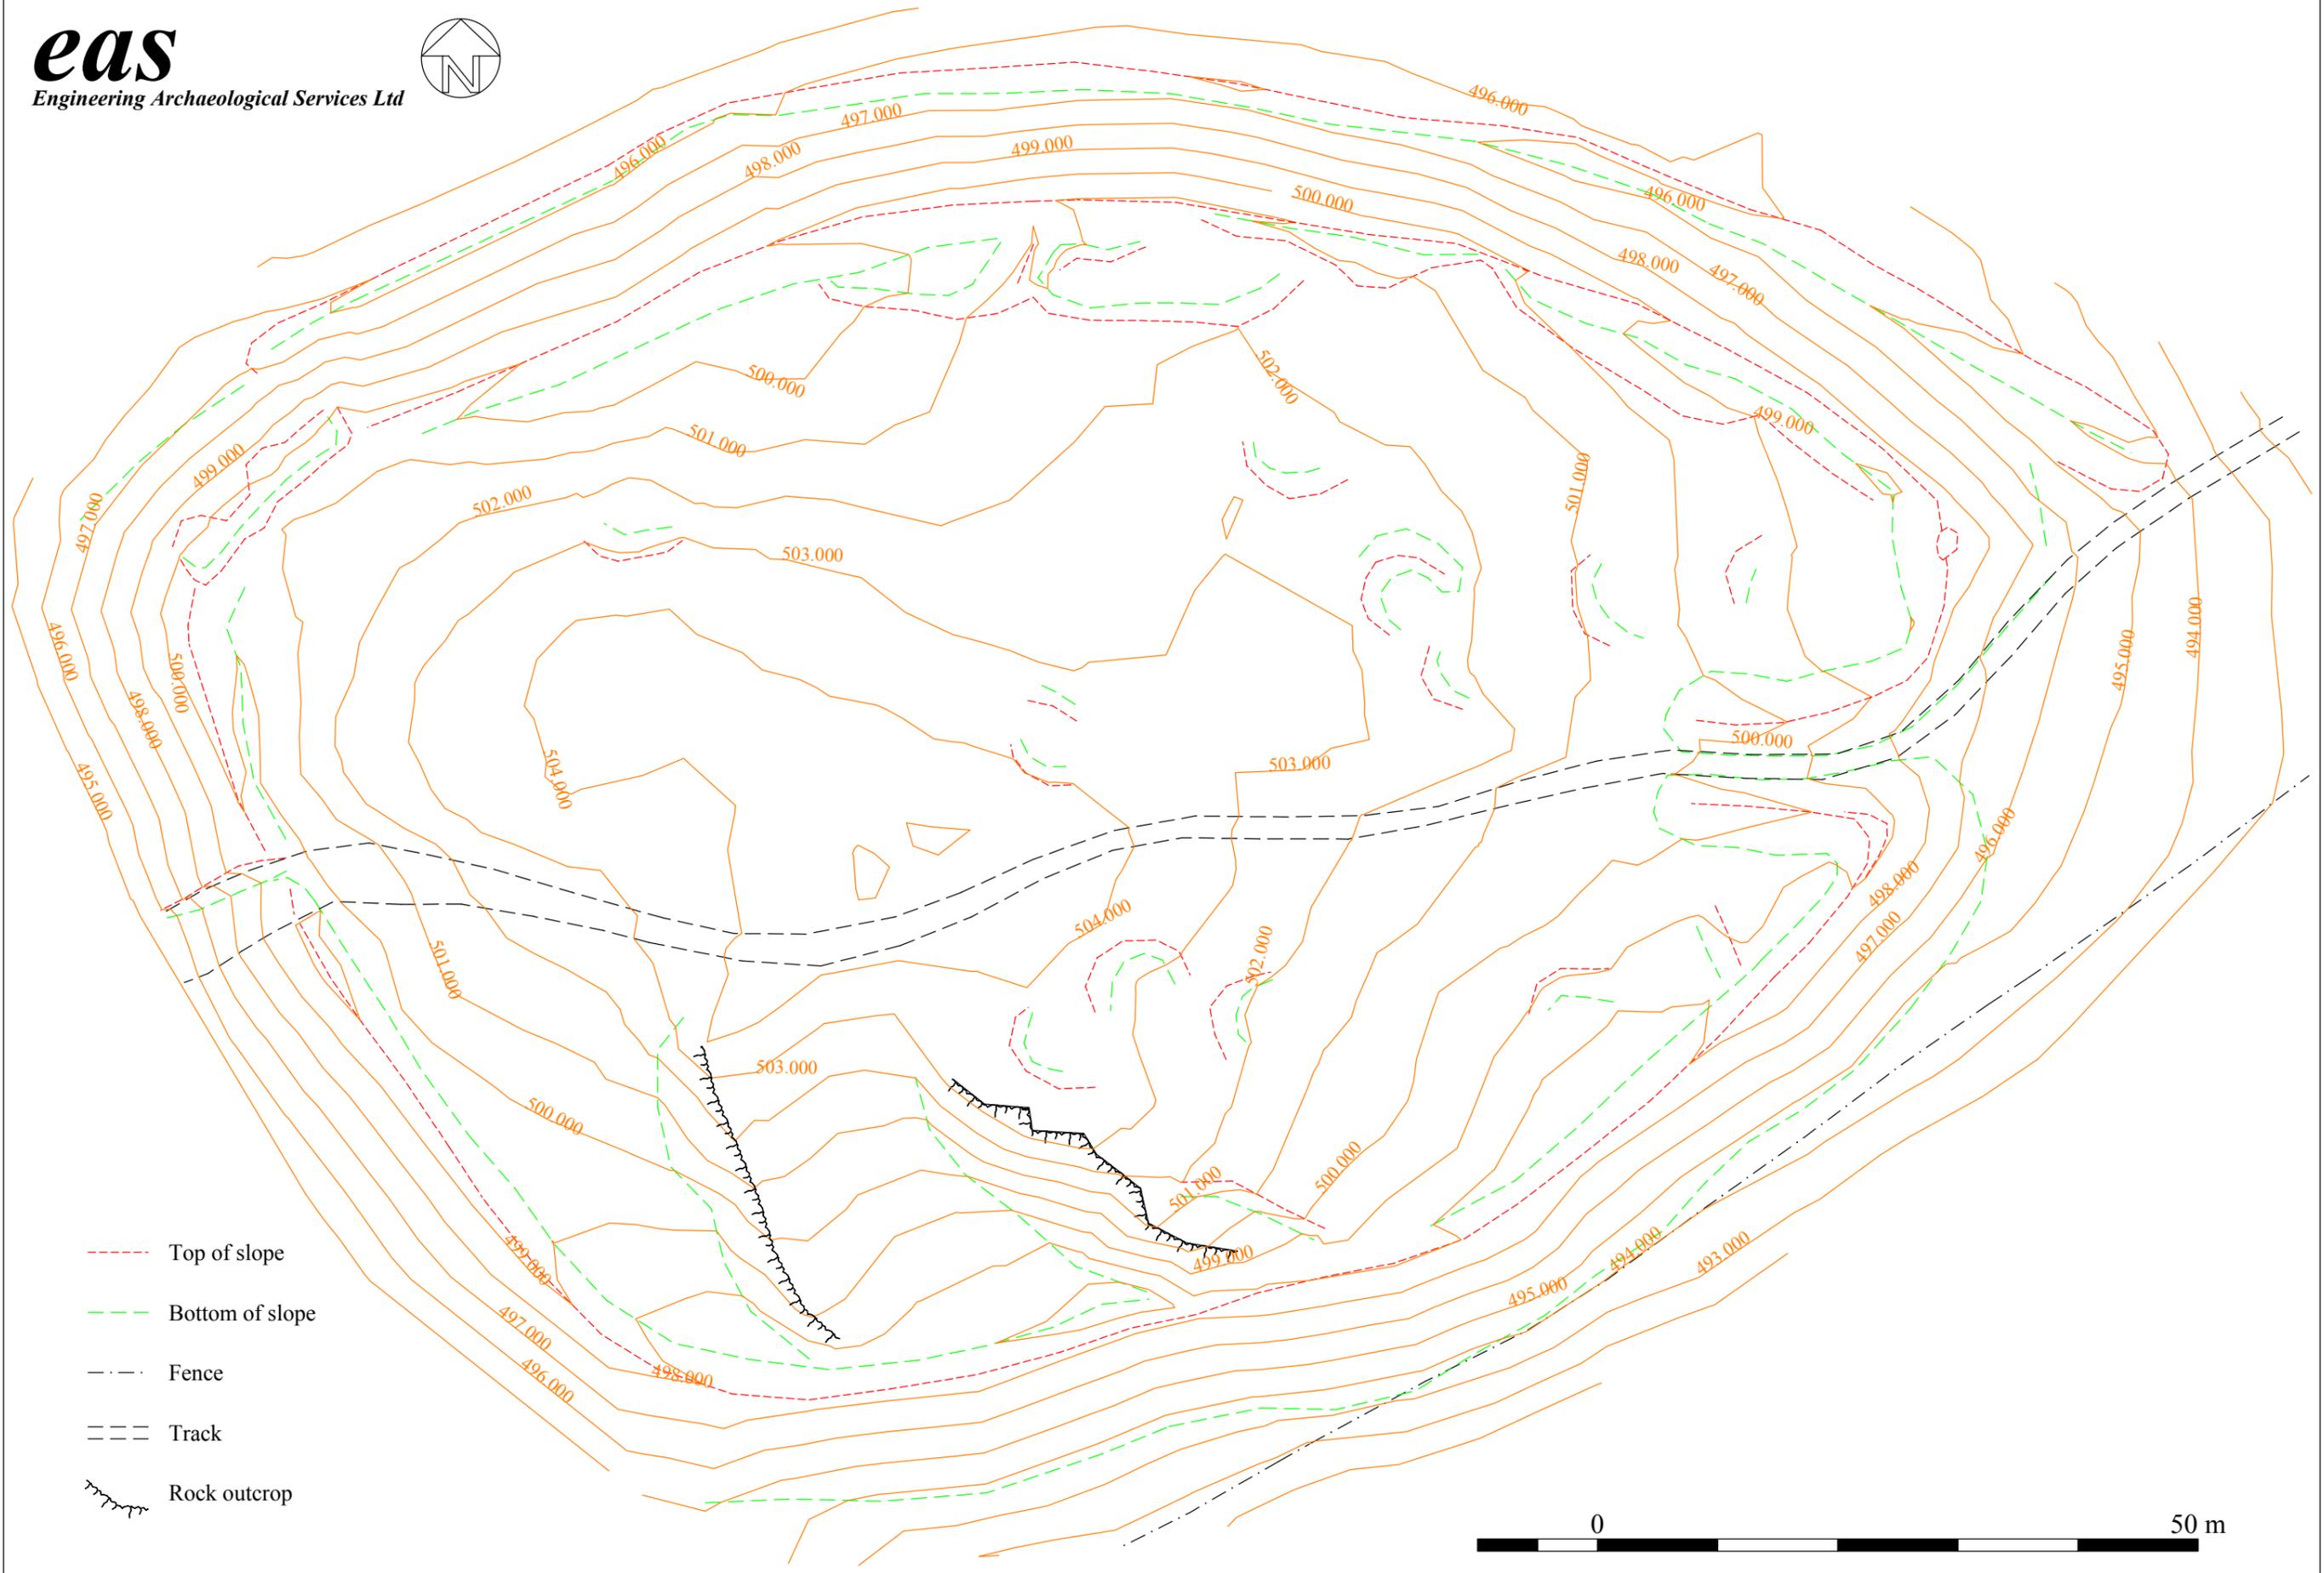
The single rampart at Moel y Gaer, Llantysilio encloses an area of approximately 0.95 ha. It is most developed on the northern and eastern sides of the hillfort where an external ditch is also evident. Elsewhere the defences would appear to consist of a single rampart which enhances the natural slope of the hillside. Quarry hollows occur only in the north eastern sector.

Only one gateway is evident. This has an inturned corridor, approximately 22.25 m long and 2.25 m wide. Either side of the corridor itself the rampart appears to have two platforms consisting of sections of the ramparts which are wider and slightly higher than the general pattern. The southern platform is

at the eastern end of the southern side of the corridor, whilst the northern platform is approximately 14 m north of the entranceway. The function of these platforms is unknown, but they appear to be distinctive design features, probably associated with the gateway.

Within the hillfort there appear to be the remains of eleven possible hut platforms. These tend to concentrate on the more sheltered eastern side of the hillfort, however the level of heather and bilberry growth within the hillfort would allow for other, more subtle features to exist.

Major erosion within the hillfort is concentrated on the track which crosses the site. This enters through the gateway, crosses the site and then continues, across the western rampart, before extending into the landscape. This track is still being used by motor vehicles and remains a constant threat to the remains. Where the track crosses the western rampart, the rampart has been completely destroyed and the possible pre-rampart ground surface is exposed.

The modern track, used by motor vehicles as well as walkers, remains an active source of erosion. It is probably impossible to completely stop or control this activity and to some extent the damage has already been done. Two points of particular concern remain, however, where the track runs through the gateway and crosses the western rampart. Monitoring of the erosion occurring at these two points may reveal constructional details and pre-hillfort deposits which should be recorded whenever possible.
